Palace of Fine Arts Engineering + Use Study

PHASE I:
existing conditions assessment
November 21, 2013

ehdd.

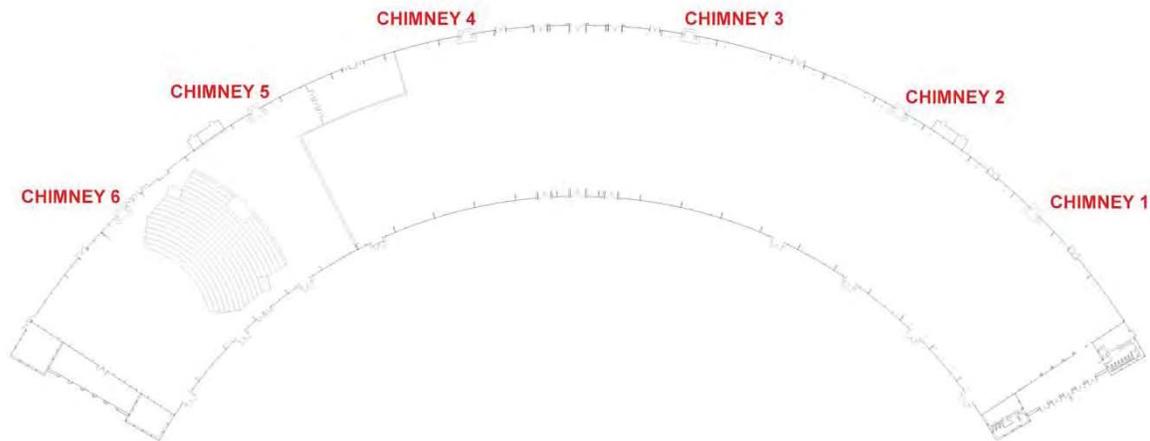
Figure 01: Chimney key plan.

The cement plaster at chimney 5 on the west facade poses a concern due to severe cracking (see Figure 01 for key plan). Assessment by the structural engineer and review of past project drawings, the cracking is believed to be caused by corrosion of the steel strap, installed to brace the chimney.

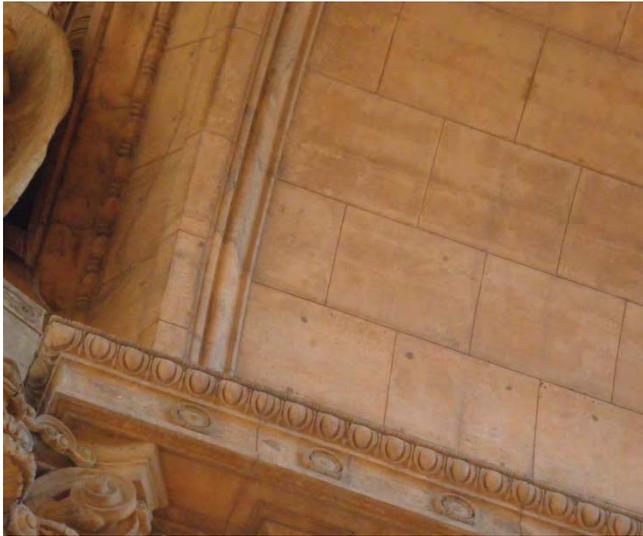
Spalls and structural pinning of the cast concrete were completed, as described in the summary of the 2008 stabilization project. Spall patches and plugs for the pins are a close match to the original concrete. There are several that stand out due to the discoloration of the existing concrete. Industry standard is to match to clean concrete and not stained or dirty concrete, allowing the patch to weather and eventually blend. A future project should follow this same standard. Currently the concrete only suffers from minor staining due to bird droppings. A future project should consider a bird management plan to arrest roosting habits on the structure.

Figure 02: Rotunda arch showing plugs from pinning.

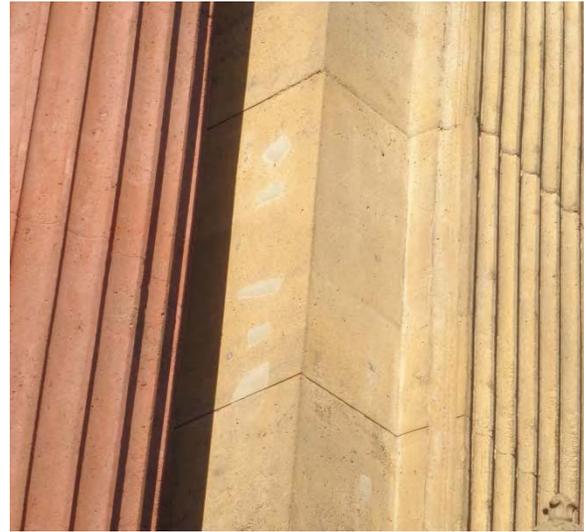
Figure 03: Spall patches.

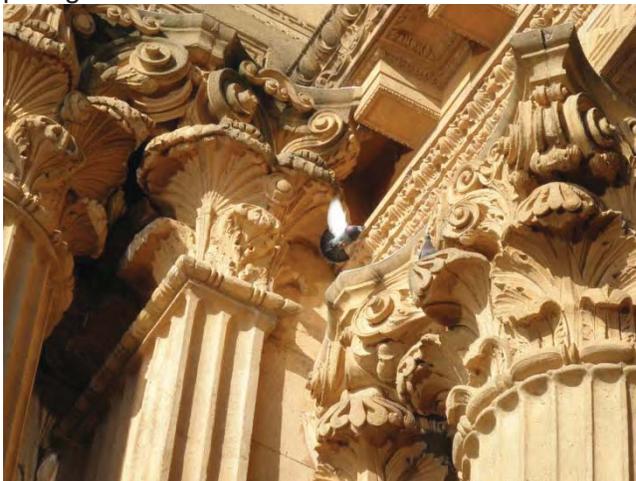
Figure 04: Pigeons roosting at Colonnade.

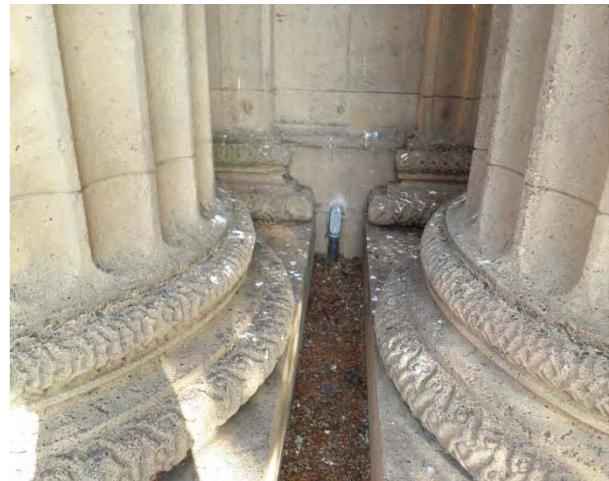
Figure 05: Bird droppings staining concrete.

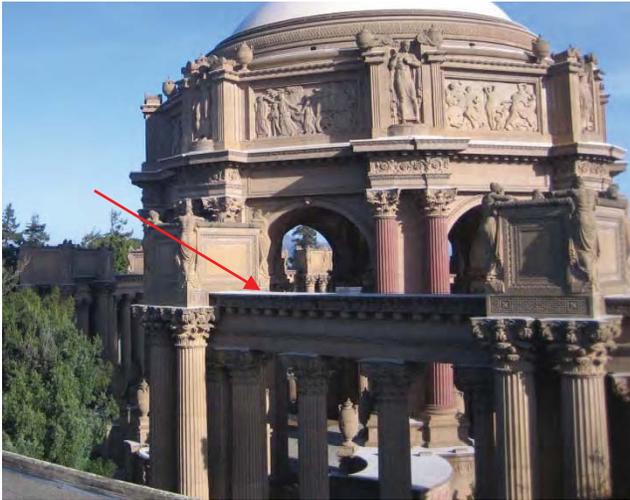
The recent 2008 project included a parge coat at all horizontal ledges of the rotunda in an effort to mitigate water infiltration. Damaged plaster was repaired and painted. No signs of water infiltration were visible from the ground level. Additional investigation and access to the space above the ceiling are recommended to assess the condition of elements not accessed during this survey and to advise on repairs.

Figure 06: Parge coat installed at horizontal surfaces.

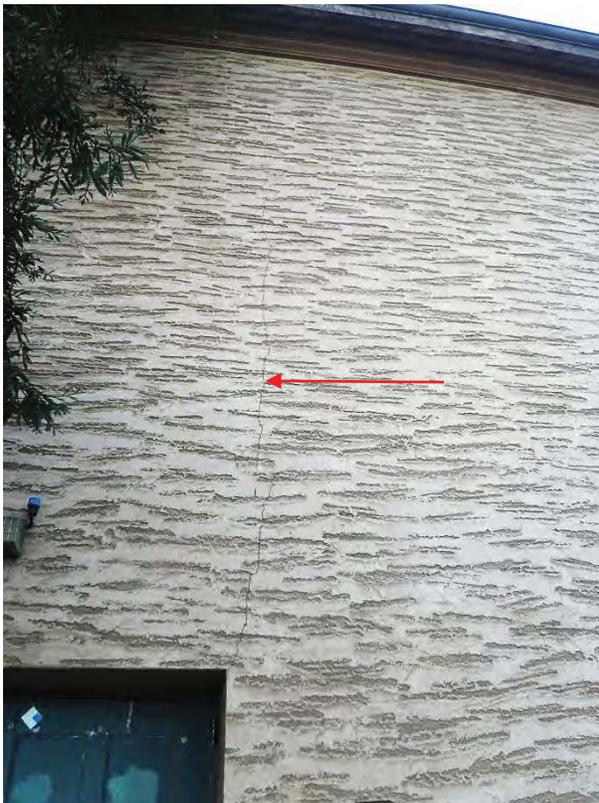
Figure 09: Vertical crack at door on west façade.

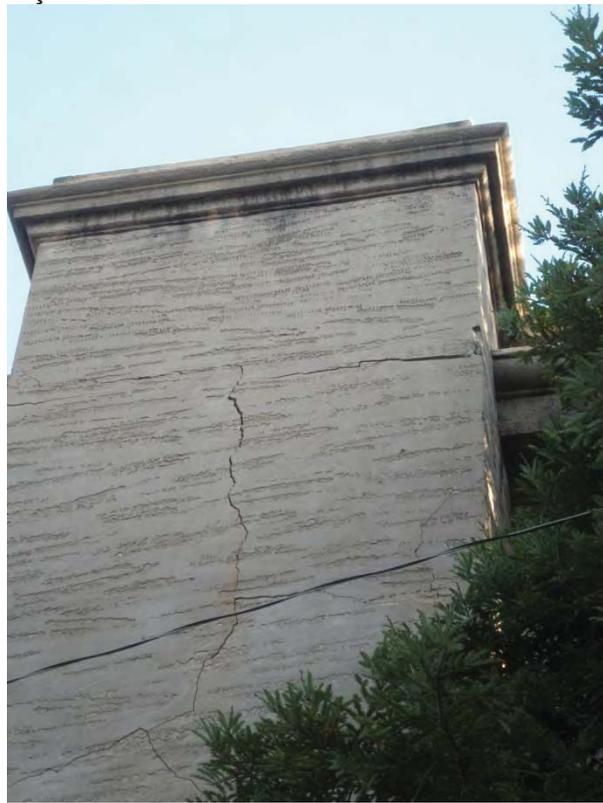
Figure 10: Severe cracking at chimney located second in from the south edge of the west façade.

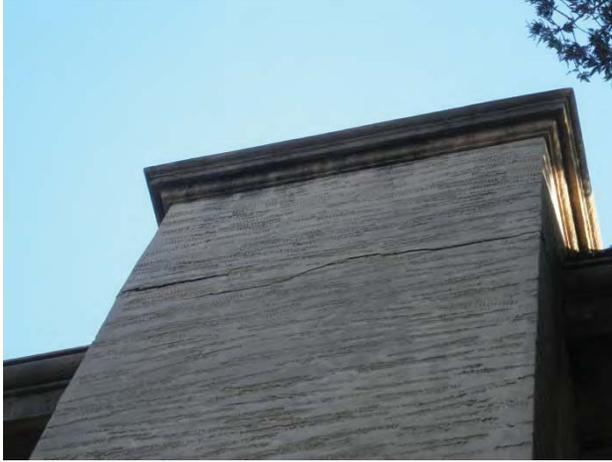
Figure 11: Horizontal cracking at chimney.

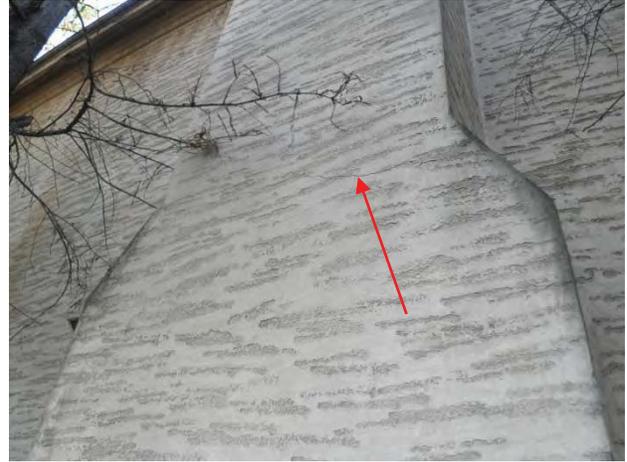
Figure 12: Typical minor cracking at chimney.

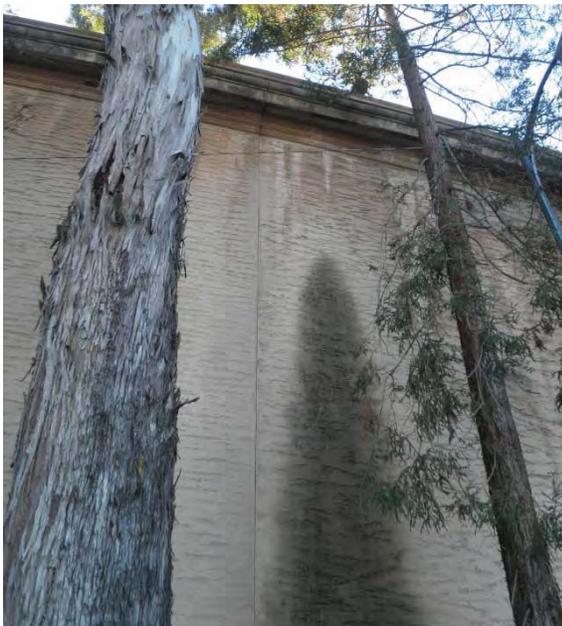
The extensive water staining and organic growth is primarily a result of the failure of the downspouts to properly shed water from the roof, forcing water through the overflow scuppers. When water is shed through the overflow scuppers it cascades down the exterior façade of the building. This provides a wet environment that is ideal for organic growth to blossom and grow. Currently the downspout drains are clogged with debris of the nearby redwood trees and should be cleaned. Additional organic growth can be found at the cornice of the east façade. A future project should consider the following:

Figure 13: Example of water staining and organic growth at overflow scupper location.

- Study the ability of existing downspouts to handle the volume of water shed from the roof. Provide additional interior downspouts where needed;
- Scope existing downspouts to determine if blockage exists deeper within the system;
- Clean organic growth stains from cement plaster using mild detergent and natural fiber brush;
- Consider trimming/removing redwood trees.

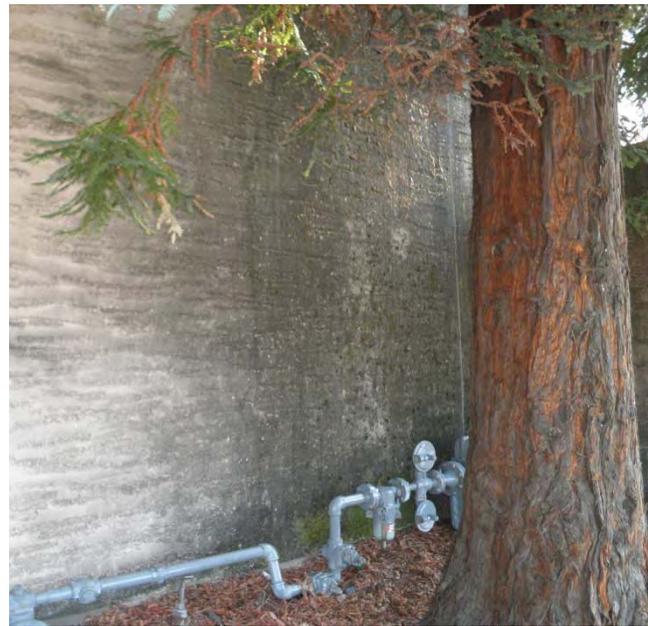
Figure 14: Area of severe staining and organic growth.

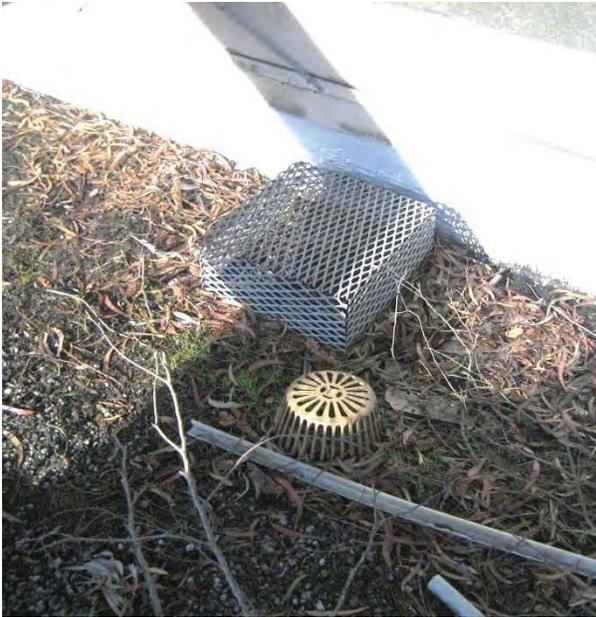
Figure 15: Example of clogged downspout and scupper at roof.

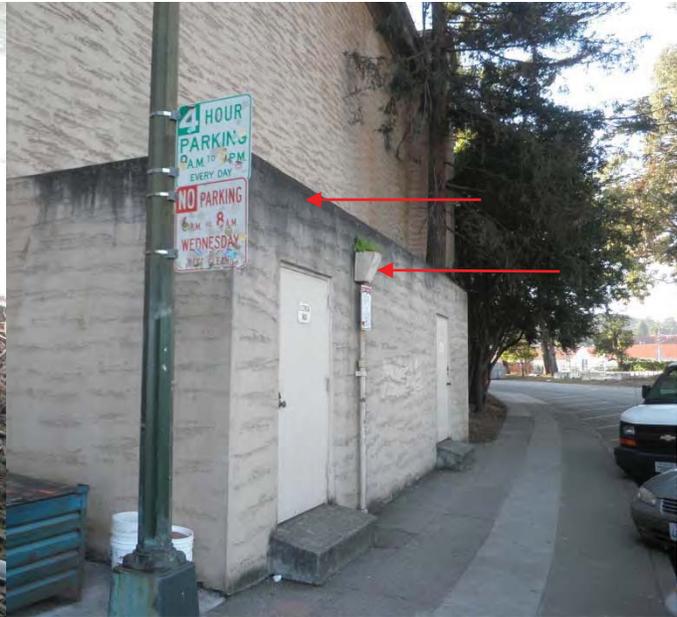
Figure 16: Clogged leaderhead and resulting staining and organic growth.

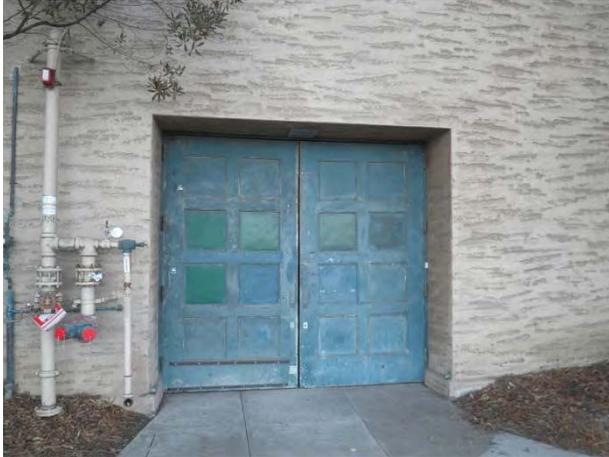
Figure 17: Typical historic door at west façade.

Original door hardware does exist. The 1993 HSR should be referenced for its location. As previously noted the hinges generally are in need of repair. All original hardware should be rehabilitated to proper working order and cleaned to remove paint and corrosion. Where hardware is not code compliant for door use, consider relocating the hardware to a door to be fixed in place and provide proper documentation of the change.

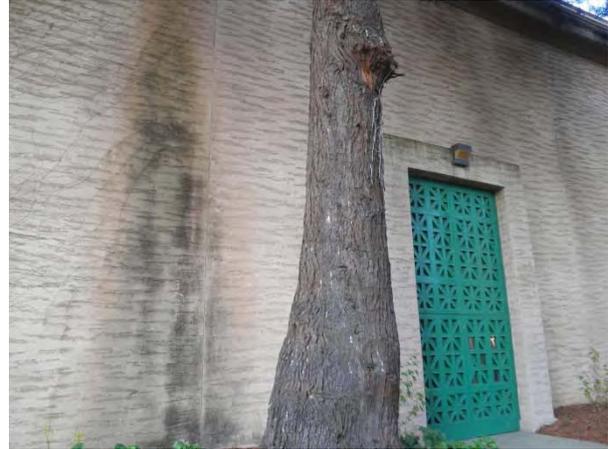
Figure 18: Typical door at east façade. Also note staining of plaster.

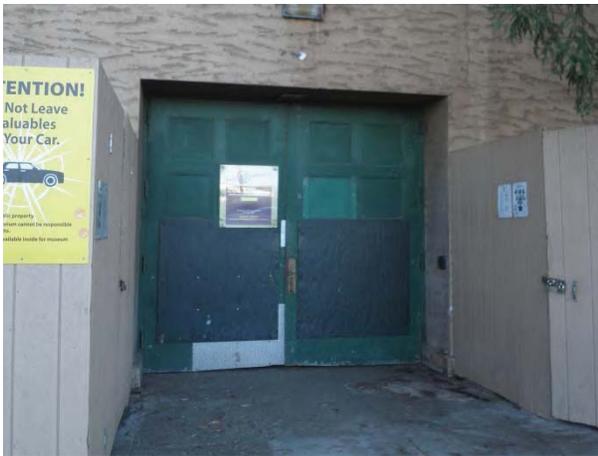
Figure 19: Plywood and metal kick plate at base of historic doors on west façade.

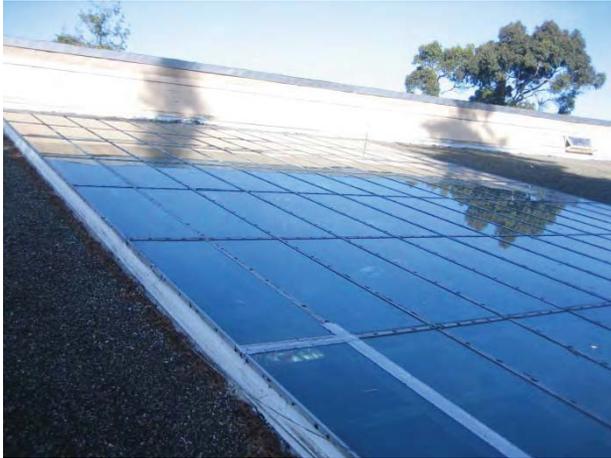
Figure 21: Skylight with replaced glazing.

others with tempered glass. If the roof is replaced as part of a future project the flashing system at the skylight curb should be replaced.

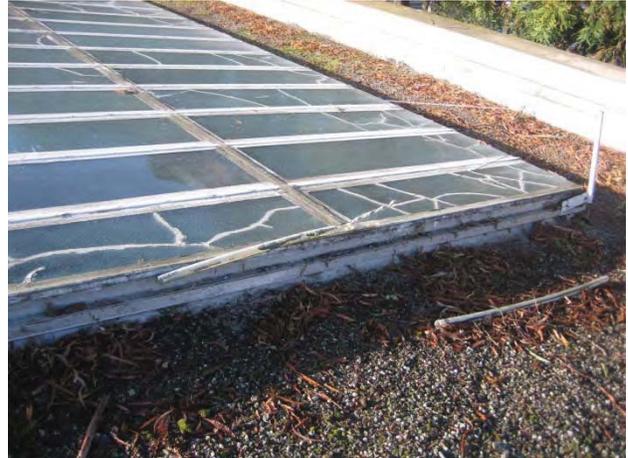
Figure 22: Skylight with cracked glazing and bituminous tape.

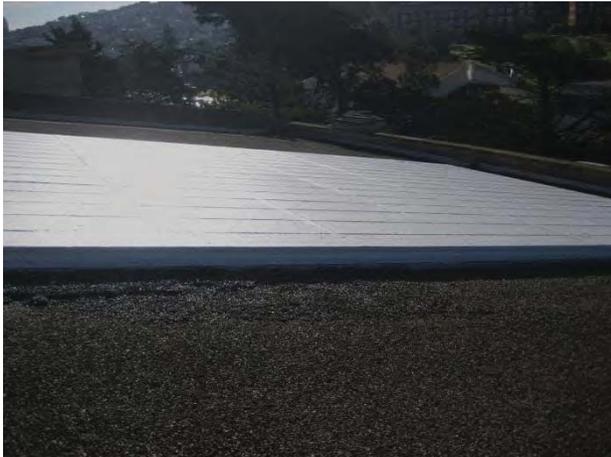
Figure 23: Skylight painted over.

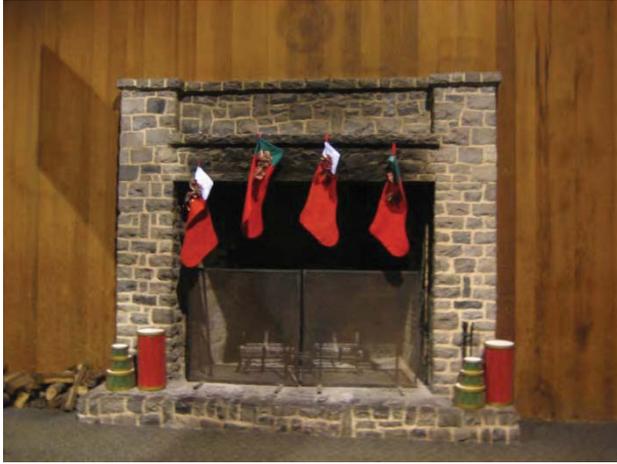
Figure 23: Fireplace at theater lobby still in operation.

The original stone of the chimneys can be observed from the interior, with the exception of one which is furred over and not accessible for assessment. The stone work is in good condition with some general soiling due to soot. Only the theater lobby fireplace is currently in operation. Chimney caps were observed from the roof and are in various states of disrepair. Caps should be replaced as part of a future project. Should a future project wish to make chimneys operational, it is recommended they be cleaned (swept) and inspected.

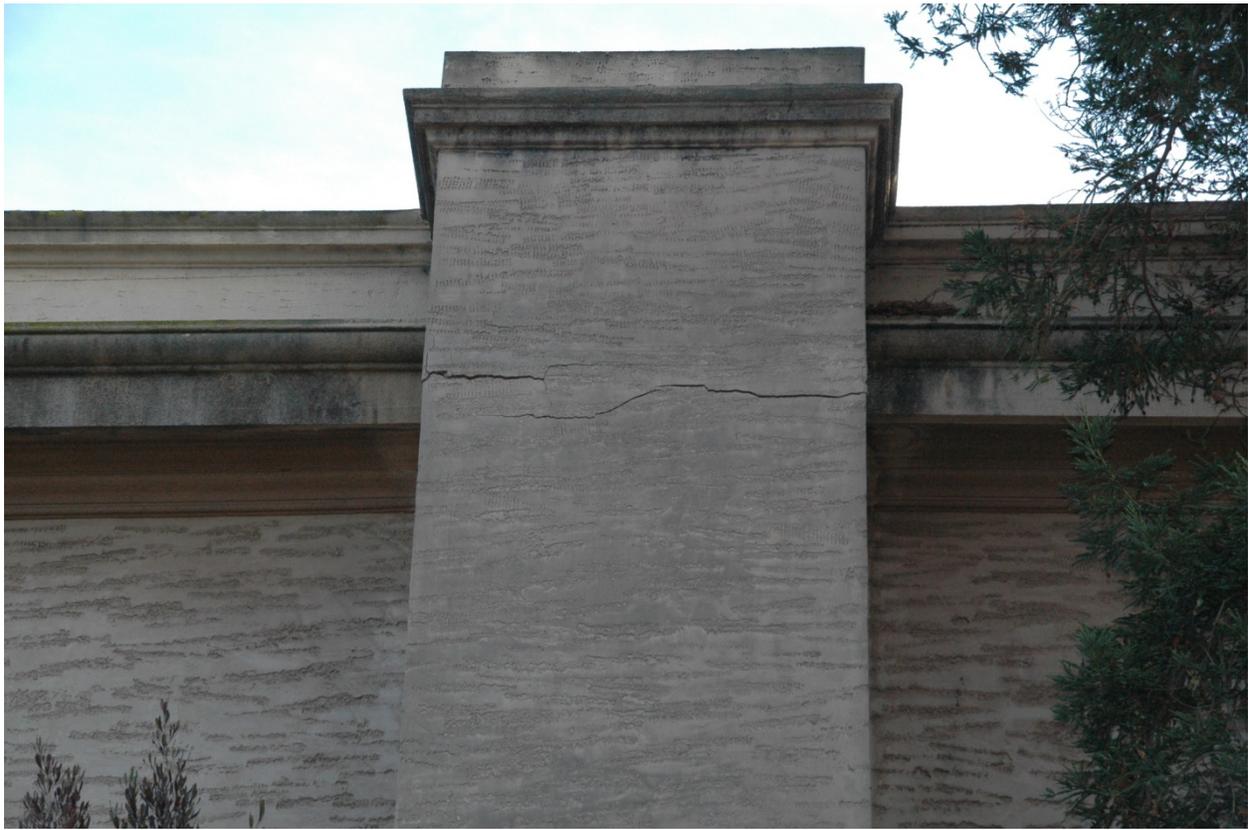
Top of Chimney Near Grid 9

Photos of chimney conditions.

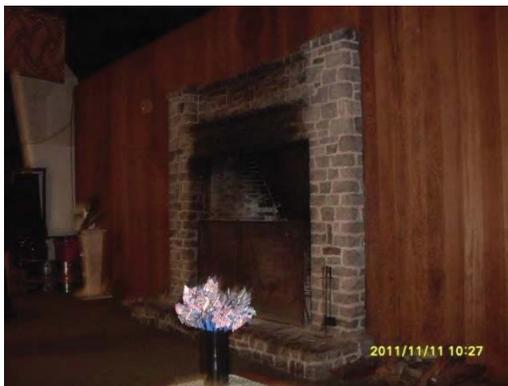
Six large wood-burning open fireplaces are equally spaced along the north wall of the building. Building operators report that the fireplaces are occasionally used and remain in decent operational condition. The fireplace in the Theater area is the one that is used most frequently. Visual inspection did not reveal any flue-dampers located in the chimneys.

Existing open wood-burning fireplace

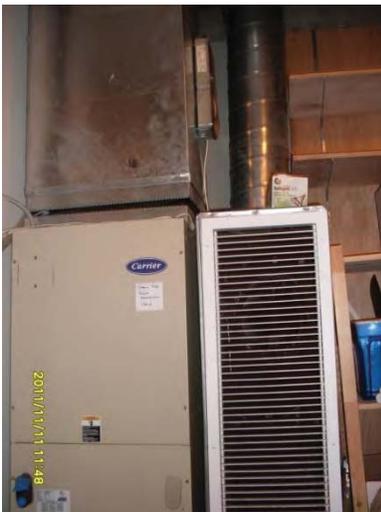
Enclosed office and classroom areas are served by a number of small residential-style or packaged- units located on the roof. All equipment appears to be constant volume with local electronic thermostatic controls. Thermostats are residential style without the ability to independently schedule the fan separate from the heating/cooling functions. As such, the units cannot be controlled to provide code-required ventilation for occupants.

Heating/cooling single-zone unit serving an office suite
