Palace of Fine Arts Engineering + Use Study

PHASE I:
existing conditions assessment
November 21, 2013

ehdd.

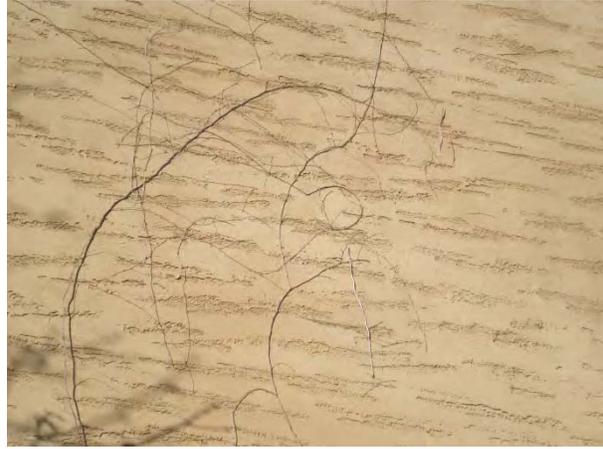
Figure 08: Old ivy organic growth at east façade.

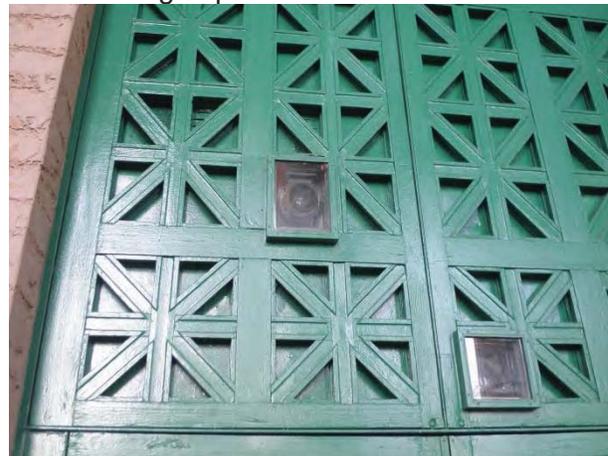
Figure 20: Inappropriate alteration of historic doors on east façade.

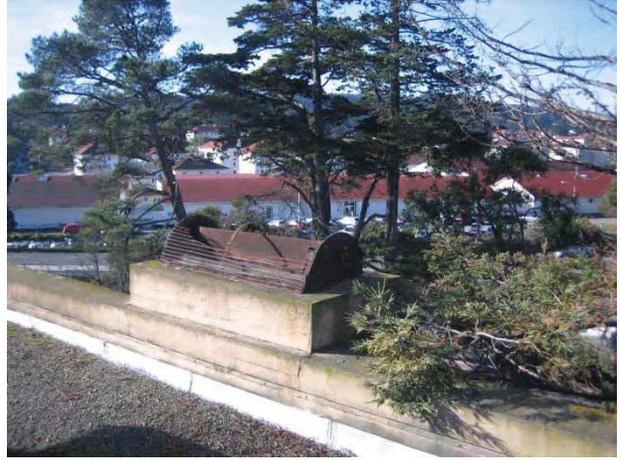
Figure 24: Chimney cap in disrepair.

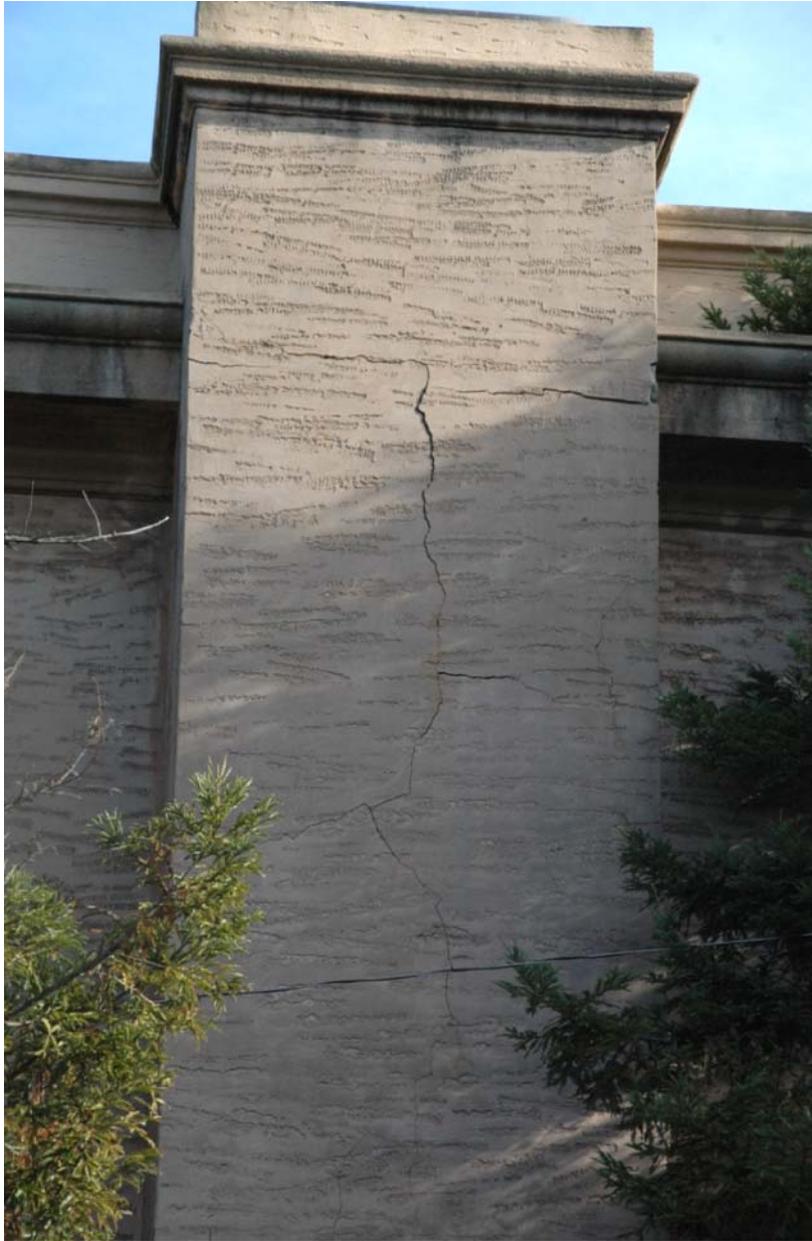
Chimney Near Grid 5

The cement plaster at chimney 5 on the west facade poses a concern due to severe cracking (see Figure 01 for key plan). Assessment by the structural engineer and review of past project drawings, the cracking is believed to be caused by corrosion of the steel strap, installed to brace the chimney.

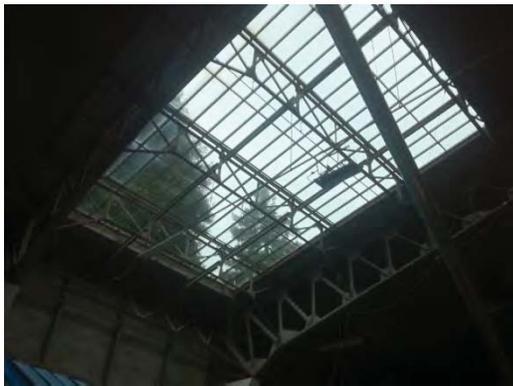
The exterior is painted concrete with multiple large metal doors and a metal roof. There is no thermal insulation evident on the exterior walls or metal roof. There are large existing skylights that consist of metal frames and single-glazing. The thermal envelope for the building is poor.

Existing Single-Pane Skylight

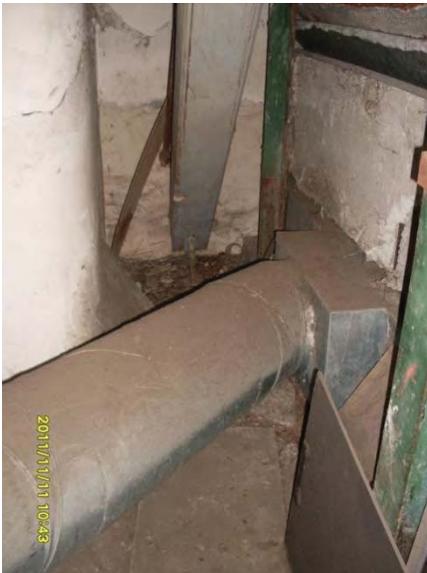
The furnaces are organized into two banks of four furnace units that are controlled as a single air-handling unit. One of these banks is located at the northeast corner of the Theater and the other at the southeast corner. Each bank only has a small outdoor air ducted connection. For the 962 seats in the theater, a total quantity of $962 \text{ people} \times 15 \text{ cfm/person} = 14,430 \text{ cfm}$ of outdoor air should be capable of being provided to the Theater house area. The outdoor air duct connections appear much too small to be able to handle this quantity of air, so it does not appear that the equipment meets current ventilation standards.

Theater System Outdoor Air Duct

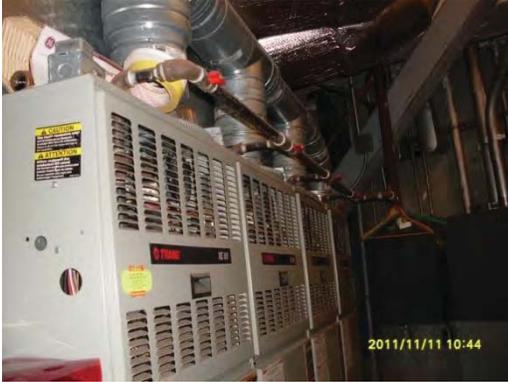
Bank of Four Gas Furnaces that serve the Theater

Theater system does not have an economizer and is controlled via a residential-style thermostat. There is no demand-controlled ventilation control in place. Theater furnace units are constant volume airflow units.

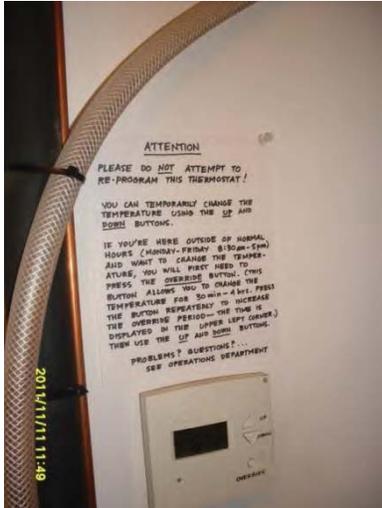
Residential-Style thermostats

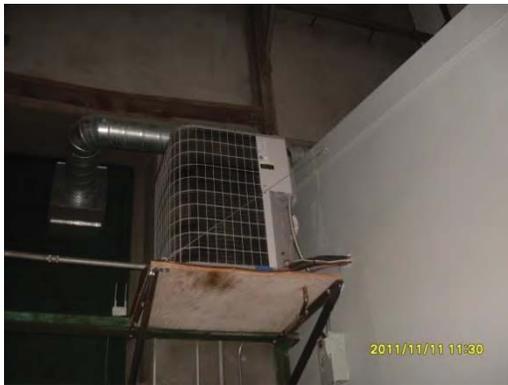
“Outdoor” condensing units are located indoors

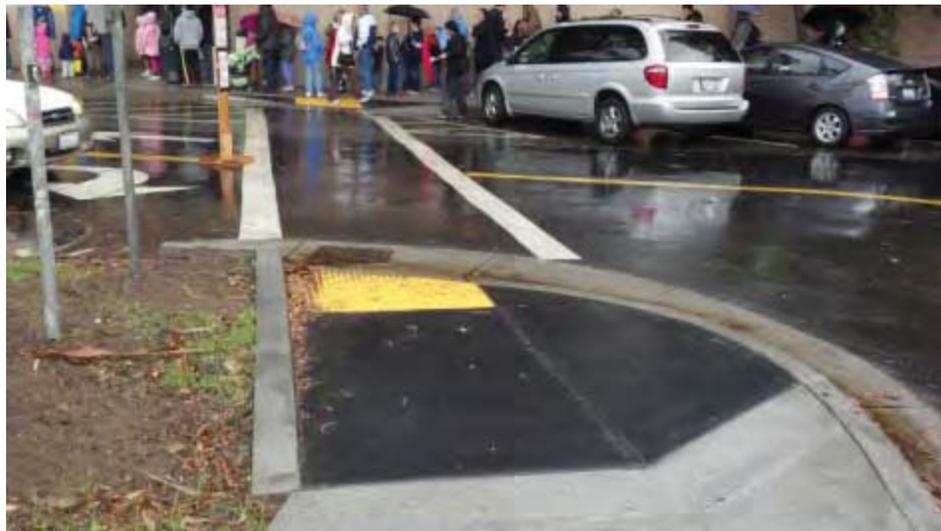
Image filename: curb ramps.jpg

- On-Site Facilities:
 - Recent construction activity has improved access to the main parking lot with a newly painted crosswalk over Lyon Street and new ADA compliant curb ramps.

Caption: Newly installed ADA ramp and crossing for the redesigned main lot.

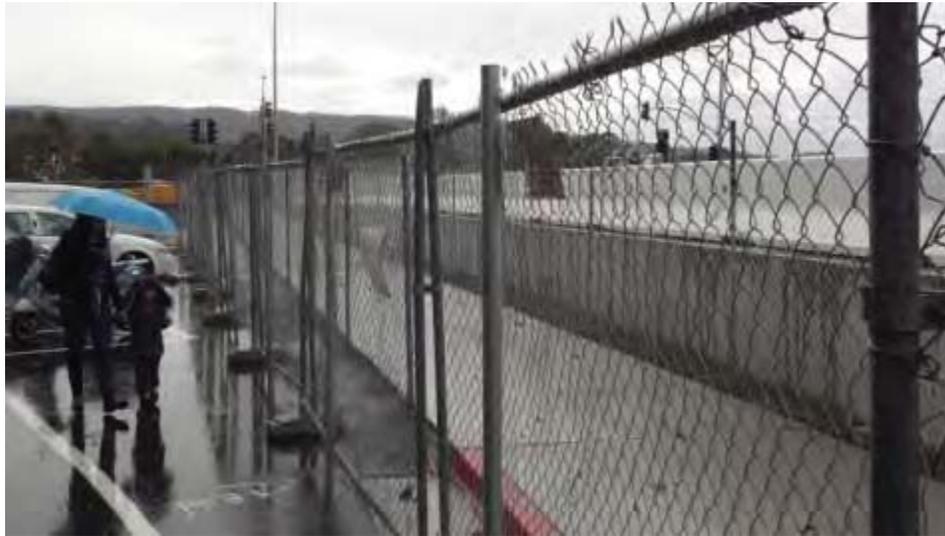
Image filename: fence.jpg

- At present, the access within the lot is severely limited due to a fenced off sidewalk that veers off to serve the new Doyle Drive by-pass rather than easy access to the

parking facility. This forces visitors to walk within the vehicle space resulting in potential pedestrian accessibility and circulation concerns.

Caption: Blocked access and poor pedestrian circulation design in the new main lot.

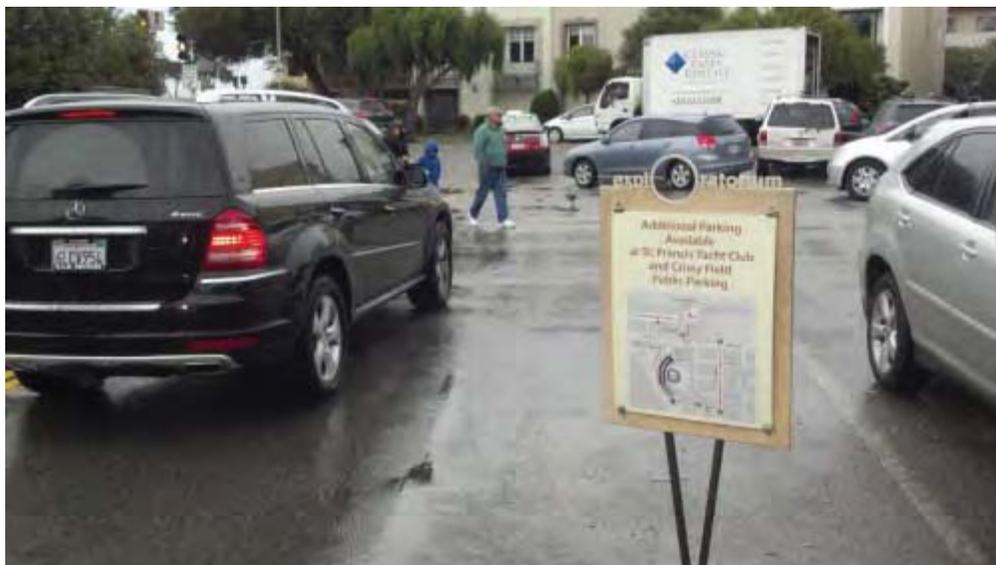
Image filename: parking directions.jpg

- Off-Site Facilities:
 - Small wayfinding signs direct drivers to additional off-site parking facilities at the Saint Francis Yacht Club and Crissy Field

Caption: Small sign directing drivers to off-site parking facilities.

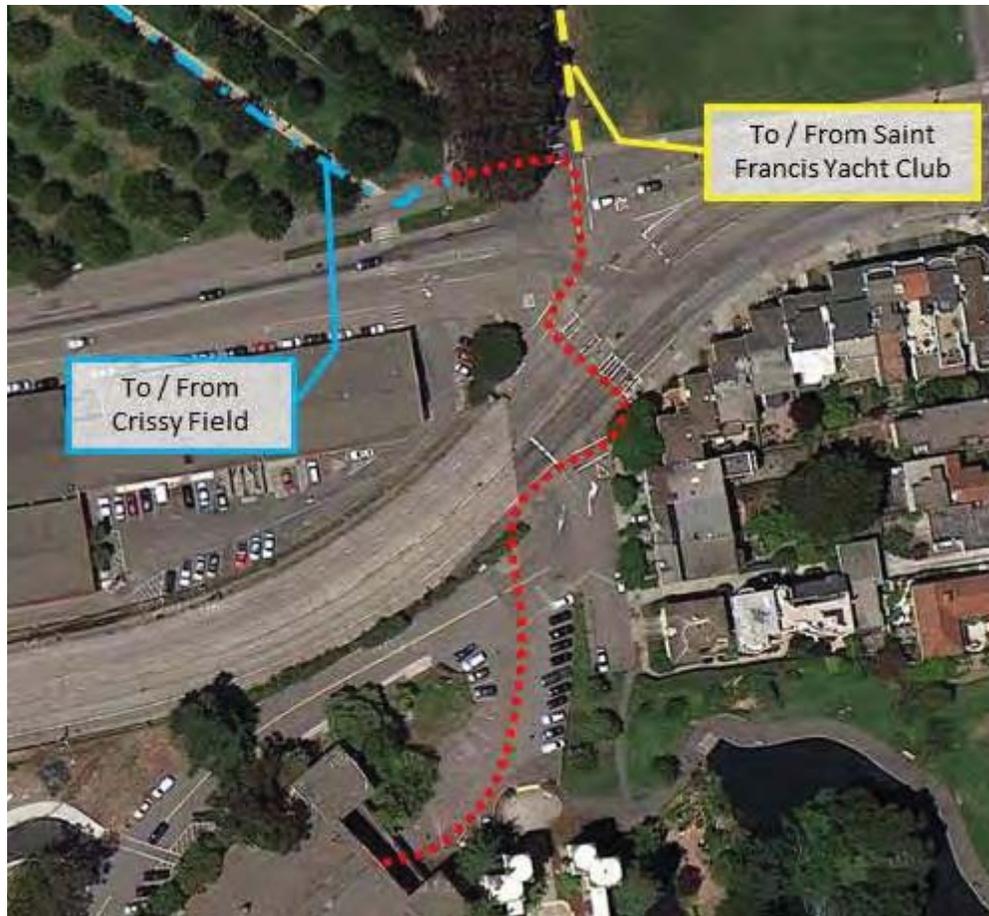
Image filename: lane crossings.jpg

- Access to and from the off-site parking is difficult and requires pedestrians to cross at least 9 lanes of traffic to get to the Palace of Fine Arts site from the Saint Francis Yacht Club parking and as many as 11 lanes from Crissy Field parking.

Caption: Obstacles to use of the nearby off-site parking options.

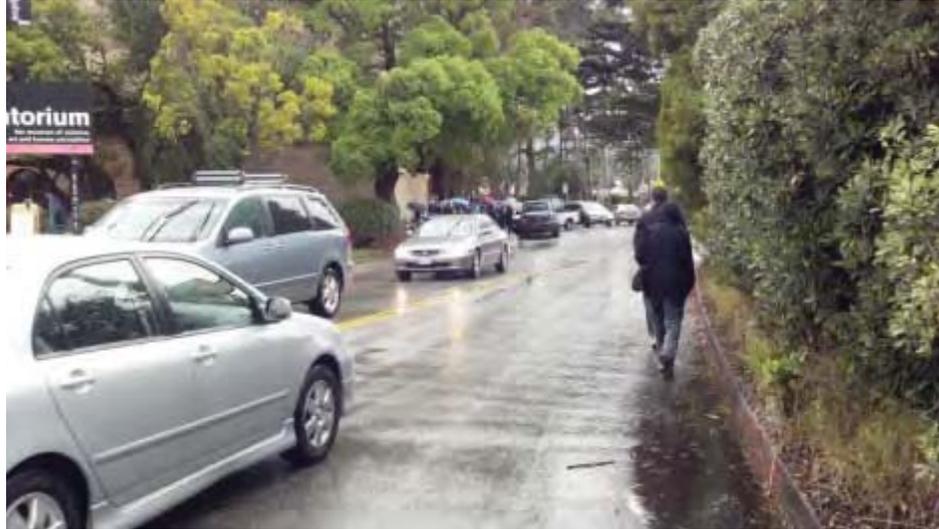
Image filename: ped conflict.jpg

Caption: Lack of road to front door pedestrian access.

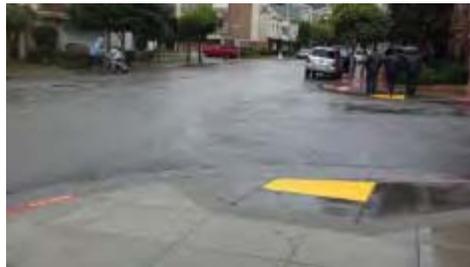
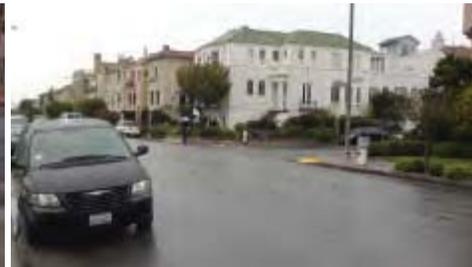
- Adjacent Neighborhood:
 - The adjacent neighborhood has pedestrian crossing curb ramps at nearly every corner although there are virtually no pedestrian crosswalk markings, likely due to SFMTA crosswalk marking standards.²

Caption: Lack of marked crossings in the surrounding neighborhood.

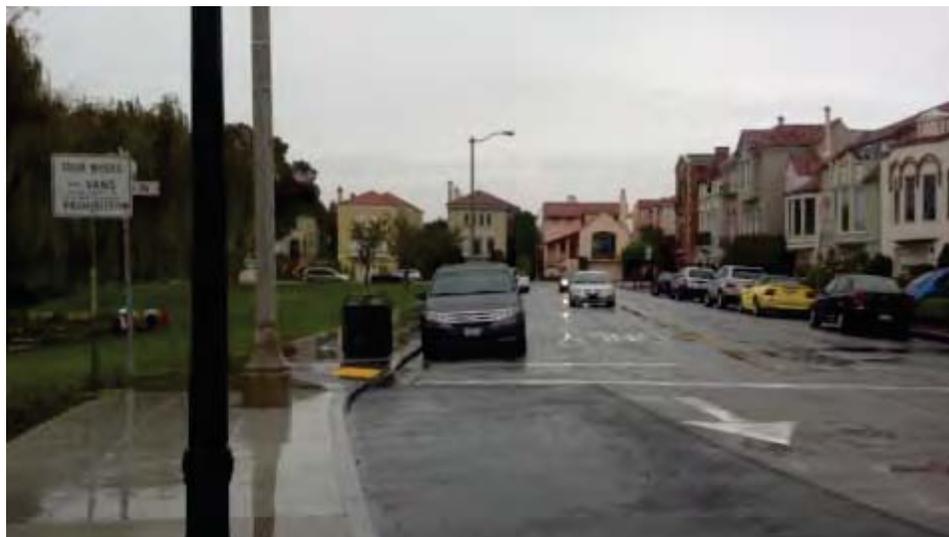
- **Tour Buses**
 - Tour buses (vehicles with seating for more than 8 people) are prohibited from entering the adjacent neighborhood streets and so are restricted to Palace Drive for accessing the Palace of Fine Arts. It is unclear how consistently this prohibition is adhered to and/or enforced.

Caption: Buses are prohibited from the neighborhood.

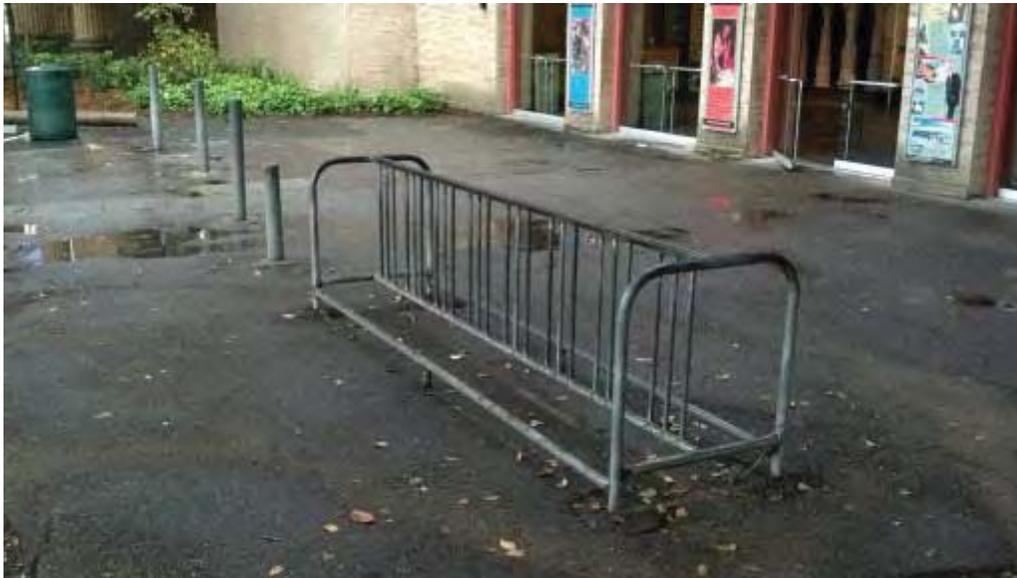
Other bicycle facilities, both Class II (on-street bicycle lanes) and Class III (on-street signed bicycle route), exist along Mason Street and other streets within the Presidio, as seen in Figure 4. Limited bicycle parking currently exists at the north entrance to the Palace of Fine Arts, at Palace Drive. This bicycle parking is suboptimal design that does little to prevent theft of most bikes with "quick release" tires; the bike parking should be updated to best practice design.

Caption: Existing bicycle parking at the front door of the Exploratorium.
