**Subject: Preliminary Study  
Geotechnical and Environmental Issues  
New Park Concept Plan  
900 Innes  
India Basin  
San Francisco, California  
Langan Project No.: 731651501**

This letter presents the results of our preliminary study regarding geotechnical and environmental issues associated with the development of the 900 Innes Avenue Park in San Francisco, California as shown on Figure 1. The 900 Innes Avenue Park is part of the India Basin Waterfront Parks Vision Plan, which includes about 60 acres of public and privately owned vacant land to be developed into new publicly accessible parkland and open space. We performed a preliminary geotechnical investigation for the adjacent India Basin Development project that includes India Basin Open Space (southernmost section of the India Basin Waterfront Parks Vision Plan), and presented our findings and conclusions in a report dated 4 September 2014.

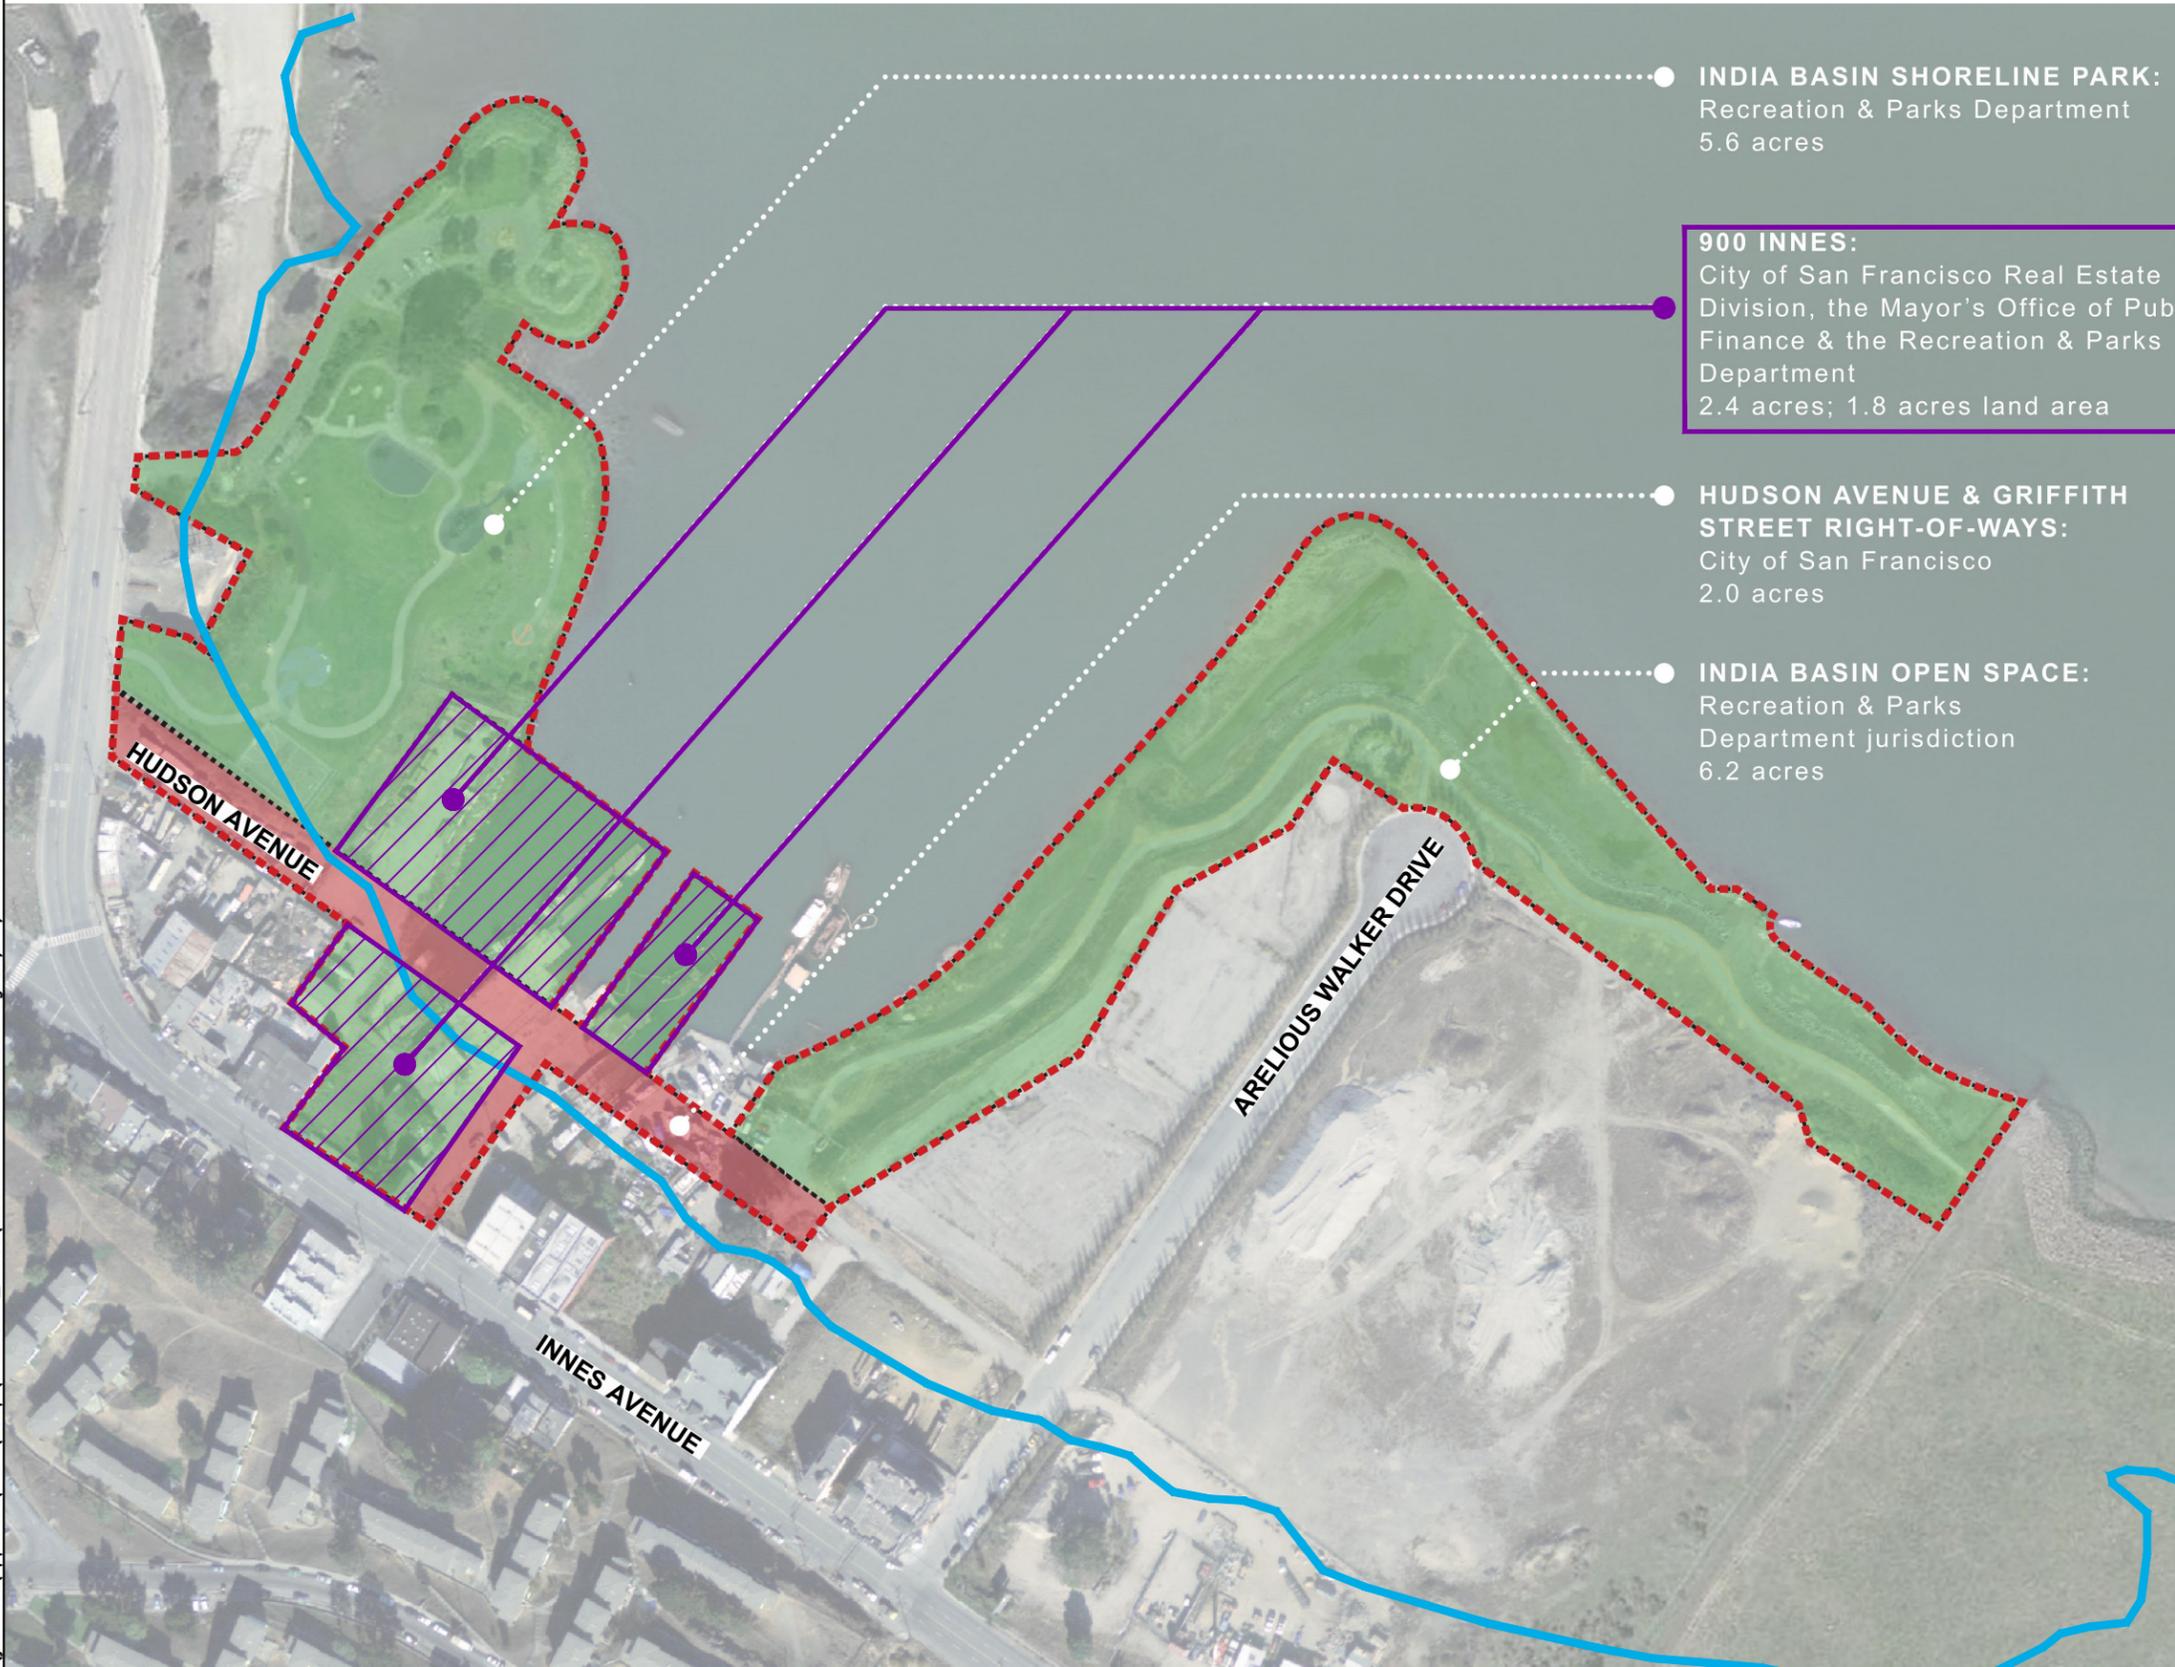
<b>900 INNES INDIA BASIN</b> San Francisco, California		
<b>SITE PLAN</b>		
Date 06/18/15	Project No. 731651501	Figure 2
<b>LANGAN TREADWELL ROLLO</b>

- **INDIA BASIN SHORELINE PARK:**  
Recreation & Parks Department  
5.6 acres
- **900 INNES:**  
City of San Francisco Real Estate  
Division, the Mayor's Office of Pub  
Finance & the Recreation & Parks  
Department  
2.4 acres; 1.8 acres land area
- **HUDSON AVENUE & GRIFFITH  
STREET RIGHT-OF-WAYS:**  
City of San Francisco  
2.0 acres
- **INDIA BASIN OPEN SPACE:**  
Recreation & Parks  
Department jurisdiction  
6.2 acres

The project site is north of the India Basin Open Space park area, east of Innes Street, and south of the proposed India Basin Shoreline Park as shown on Figure 2. The 2.4-acre site includes 1.8 acres of land. The proposed 900 Inness Avenue Park includes extending a segment of the Bay Trail along the edge of the shoreline, a continuous bike/pedestrian lane, and recreational areas including beach areas and dog parks. In addition, a driveway is proposed for boat transfer / drop off, and for emergency vehicles. Additional improvements may include the construction of a one-story, light, boat building; alternatively, the existing historic shipwright's cottage, adjacent to Innes Avenue may be retrofitted. New utilities will be installed for lighting and irrigation. Site grading may require placing 3 to 5 feet of fill.

Published maps, aerial photos, and the results of available subsurface information indicate the majority of the site is east of the edge of the historic San Francisco Bay shoreline. The approximate location of the historic shoreline is shown in the attached Site Plan, Figure 2. The shoreline was filled between 1938 and 1968.

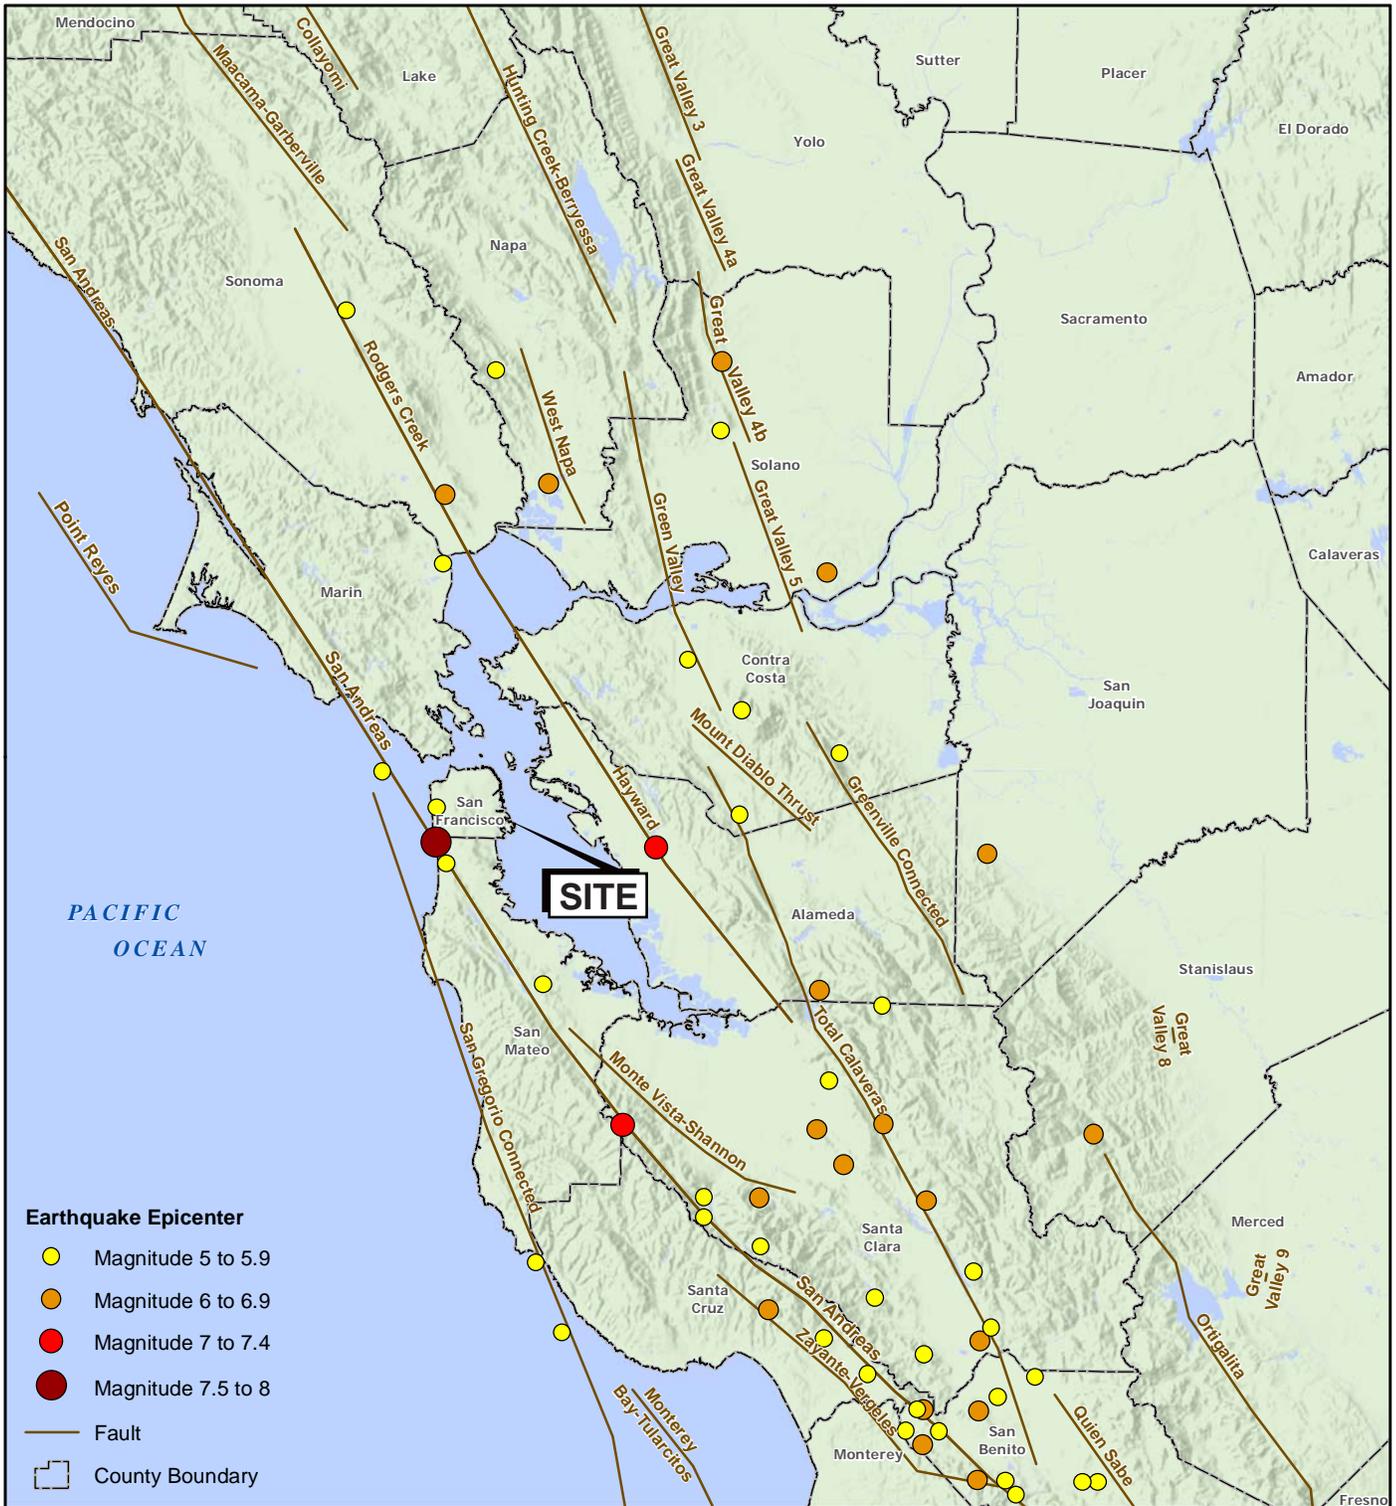
<b>900 INNES INDIA BASIN</b> San Francisco, California	<b>MAP OF MAJOR FAULTS AND EARTHQUAKE EPICENTERS IN THE SAN FRANCISCO BAY AREA</b>		
<b>LANGAN TREADWELL ROLLO</b>	Date 06/18/15	Project No.731651501	Figure 3

- Notes:**
1. Quaternary fault data displayed are based on a generalized version of U.S. Geological Survey (USGS) Quaternary Fault and fold database, 2010. For cartographic purposes only.
  2. The Earthquake Epicenter (Magnitude) data is provided by the USGS and is current through 08/24/2014.
  3. Basemap hillshade and County boundaries provided by USGS and California Department of Transportation.
  4. Map displayed in California State Coordinate System, California (Teale) Albers, North American Datum of 1983 (NAD83), Meters.

The major active faults in the area are the San Andreas, San Gregorio, Hayward, and Calaveras Faults. These and other faults of the region are shown on Figure 3. For each of the active faults within 50 kilometers of the site, the distance from the site and estimated mean

Figure 3 also shows the earthquake epicenters for events with magnitude greater than 5.0 from January 1800 through August 2014. Since 1800, four major earthquakes have been recorded on the San Andreas Fault. In 1836 an earthquake with an estimated maximum intensity of VII on the Modified Mercalli (MM) scale (Figure 4) occurred east of Monterey Bay on the San Andreas Fault (Toppozada and Borchardt 1998). The estimated Moment magnitude,  $M_w$ , for this earthquake is about 6.25. In 1838, an earthquake occurred with an estimated intensity of about VIII-IX (MM), corresponding to a  $M_w$  of about 7.5. The San Francisco Earthquake of 1906 caused the most significant damage in the history of the Bay Area in terms of loss of lives and property damage. This earthquake created a surface rupture along the San Andreas Fault
